**St. Paul's Episcopal Church
116 South Church Street
Monroe, NC 28112-5605**

**Limited Structural Observations
for
Kyle Dunn**

**by
A. Wynn Yates, PE
Yates/Starnes Engineering, PA
3300 Elstree Drive
Charlotte, NC 28226
704-650-5541
wyates@yseng.com**

July 6, 2009

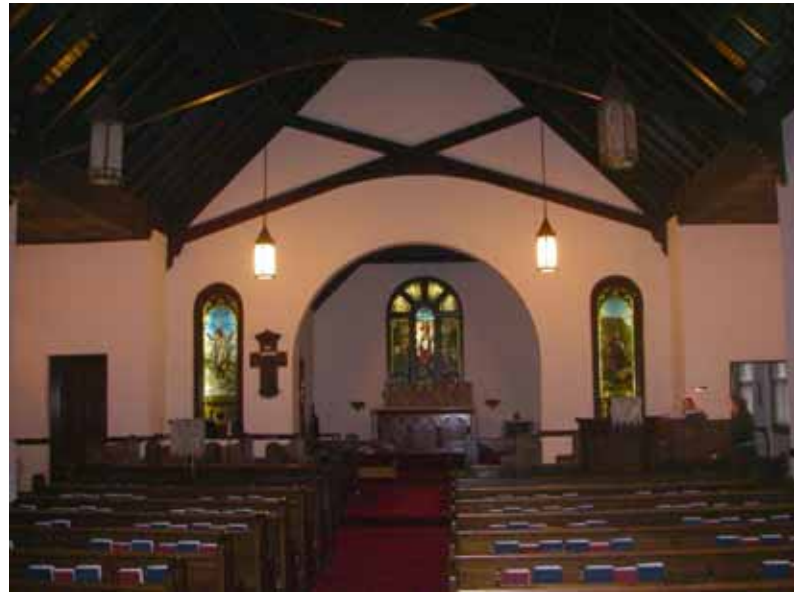
Photo #1

The purpose of this structural observation trip was to visually inspect the sanctuary floor framing members and the foundation walls that support them as seen from the crawl space. The clear distance between the nave walls is approximately 27'-10" and the length of the sanctuary/nave is reportedly 66' long. There is a 6" wide by 10" deep, dropped, timber girder that runs front to back which supports 2x10 floor joists that span from the inside face of the foundation walls to the centerline of the girder, a distance of 13'-8" (+/-).

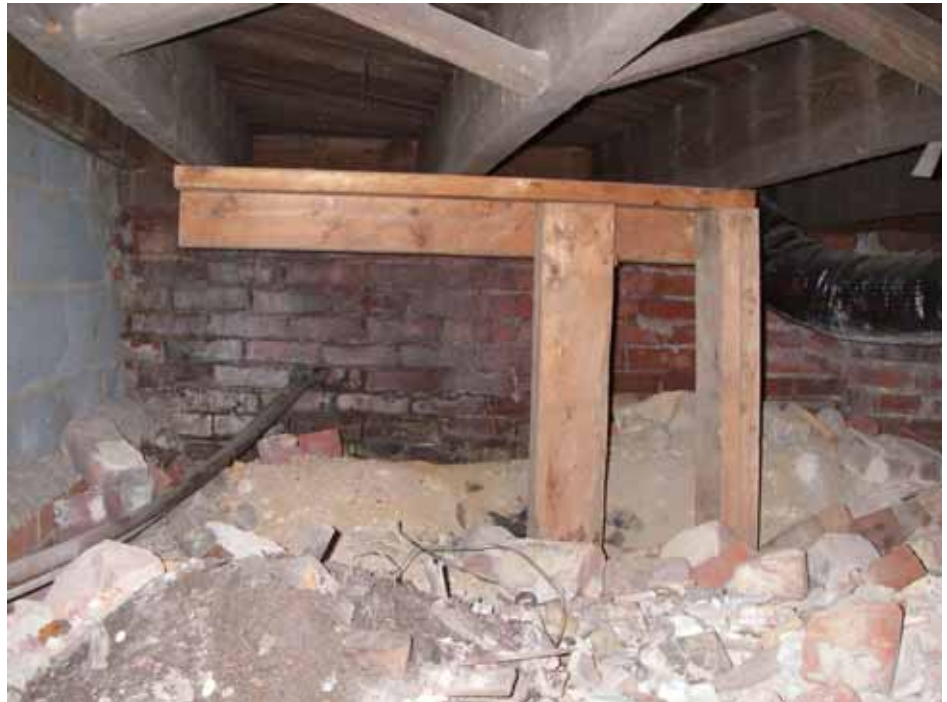
Photo #2

There is a very small partial basement under a portion of the chancel or the area just behind the chancel. This picture is taken in that area looking to the right where this improper support was added to offer intermediate support to several of the floor joists spanning approximately 13'-8".

Repair per the specifications spelled out in photo caption #5, which follows.

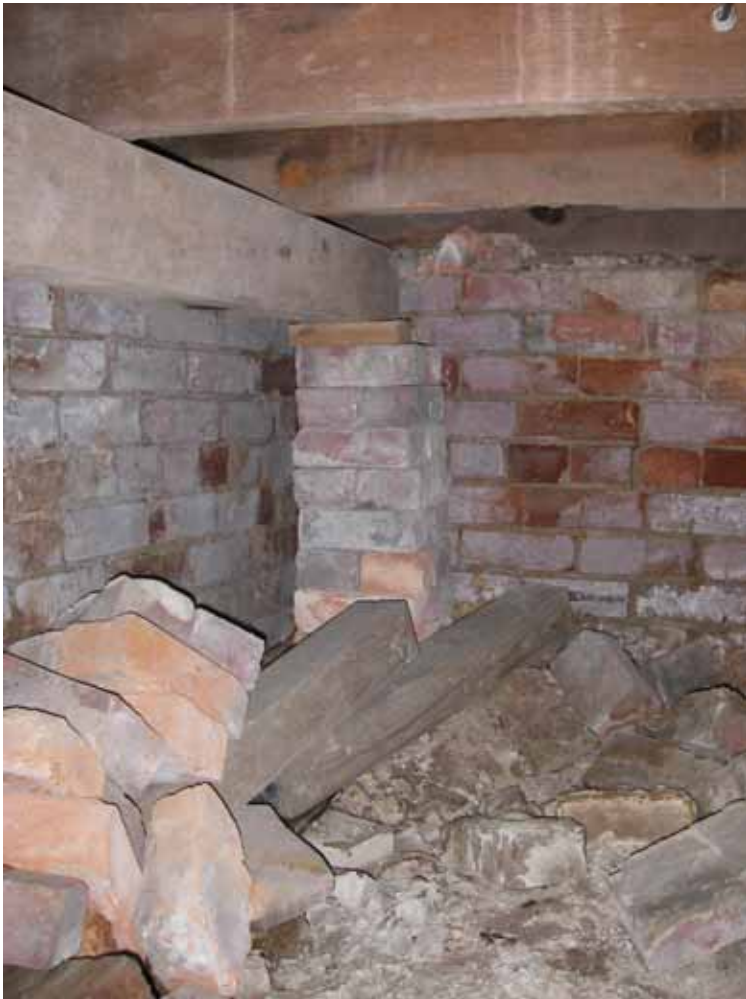
Photo #3

This picture is taken in the crawl under the sanctuary/nave at the right/front corner. It shows that a 4"x6" dropped girder was added to intercept the 2x10 (actual dimensions) floor joists loads just to the inside of the left foundation wall.

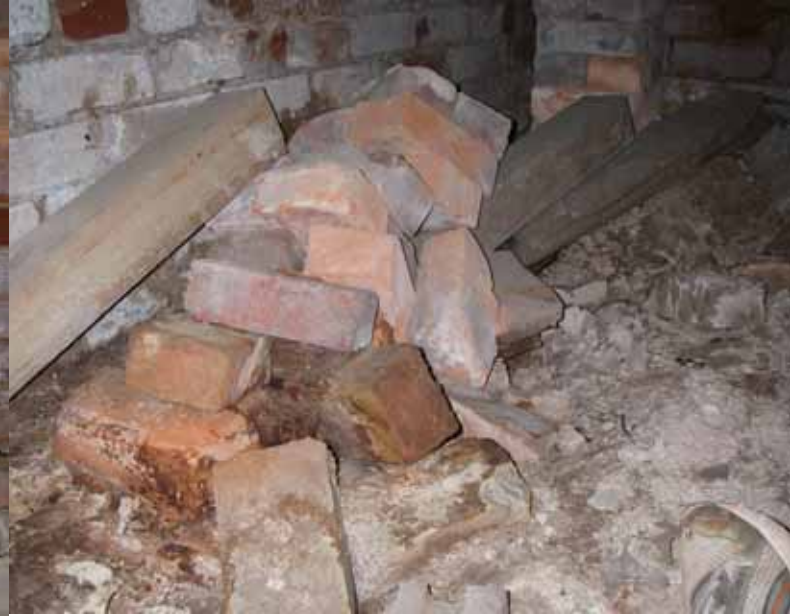
Photo #4

This picture shows the same dropped girder with missing support. Dry-stacked brick as seen in the previous picture has simply collapsed away from the underside of the 4x6 dropped shoring girder.

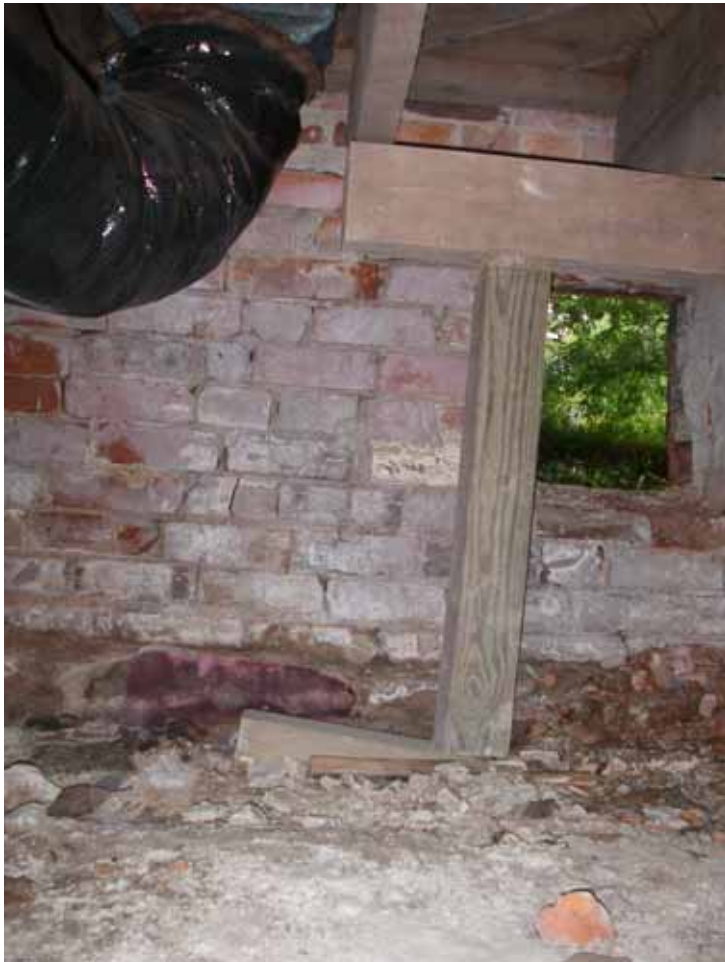
Photo #5

This is the rear end of the dropped 4x6 shoring girder, where a 4x4 wood post was furnished for support. The posts rest on flat wood, which in turn relies on the earth for support. It is clear that the intent of this shoring effort was intended to be a short-term precaution to prevent failure, clearly, the time has come to address this problem and those similar to it utilizing permanent construction techniques. Dry-stacked brick is not permitted. Wood posts that are pressure treated for ground contact are not permitted. Wood posts that are not secured so that lateral translation is prohibited are not permitted.

In this case, provide 8"x16", concrete masonry unit (CMU) isolated piers to support a 3-ply, pressure treated, 2x8 girder spanning no more than 6'-0" clear between the piers with their 16" length parallel with the girders. The new 3-ply, 2x8 dropped girder may cantilever as much as 12" at each end. Therefore the total length of the dropped girder can be as much as 10'-8". Since the spacing between joists varies from 18" to 21", the dropped girder can support up to six adjacent joists with only two CMU piers. The top 4" of the pier must be clay brick or solid solite block. The footings supporting the piers must be 24"x24"x8" poured-in-place, concrete. The centerline of the new piers must be at least 16" away from the inside face of the existing brick foundation wall, to allow ample clearance for the new concrete footing to not conflict with the continuous existing foundation wall footing.

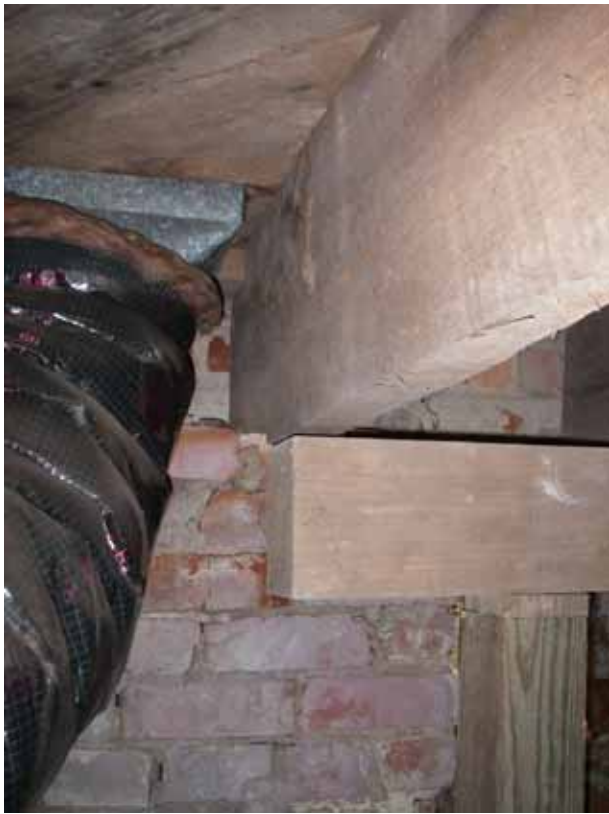
Photo #6

This is a close-up of the previous photo showing a wood shim added to the top of the 4x4 post. It was added in an effort to raise the 4x6 dropped girder enough so that it would engage the floor joist above. The visually observable gap between the top of the 4x6 girder shows that the shim at the top of the post was not adequate to provide a continuous, uninterrupted load path from 2x10 floor joists above.

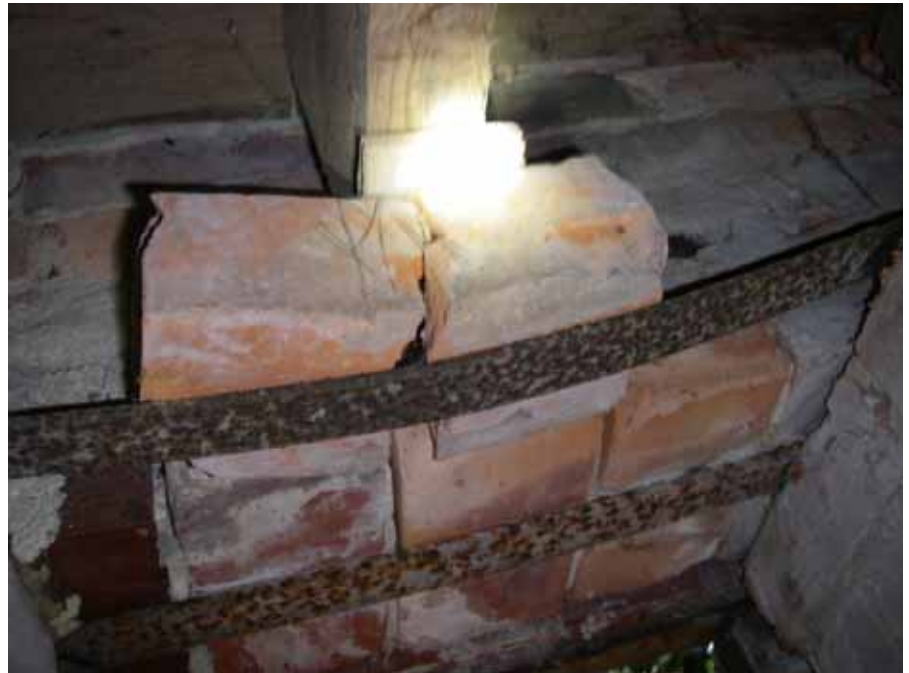
Photo #7A

This picture shows the crawl access opening on the left side of the main church sanctuary/nave building. It shows that the foundation wall is four wythes of solid brick thick. It also shows rusted metal straps used as lintels for the support of the brick over an opening that is no more than 14" wide. Besides being rusted, the straps have slipped as the mortar bed joints have deteriorated over time. The result is a joist that sits on one course of brick that is sagging badly.

As a part of the repointing project scheduled for the future, lintel conditions at all wall openings must be scrutinized to see if they require new steel supports in the form of wider flat plates, steel angles or even wide flange beams with flange plates. In the short term, this opening and the one on the left side of the crawl need new 1/4"x3.5"x3.5" angles installed at each wythe. The angles require a minimum of 4" of sound bearing on both sides of the opening.

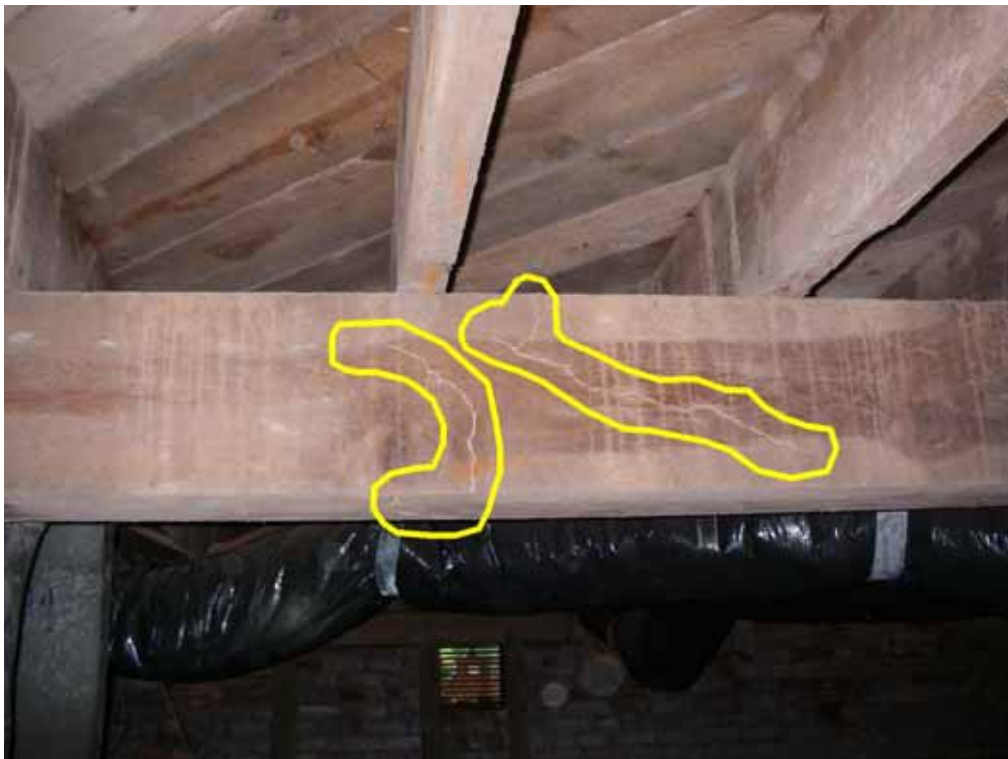
Photo #8

This picture is taken at the front of the crawl and shows the large 6" wide by 10" deep heavy timber girder that spans front to back. There is evidence of past wood destroying insect infestations. As a structural engineer, I am not certified to comment on whether or not an infestation is active or not.

Consult with a qualified specialist or with whomever you use on a regular basis to address such concerns.

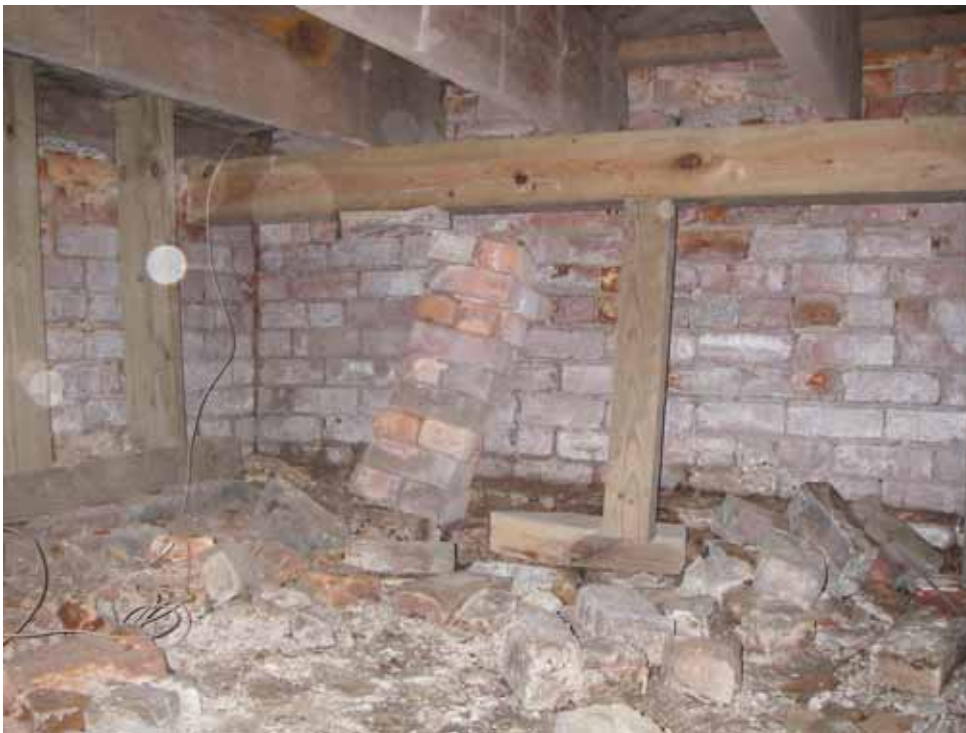
Photo #9

This photo shows the left/front corner of the crawl where the joist ends are supported by a 4"x6" dropped girder in a similar manner to that reported earlier at the right/front corner of the crawl. As can be seen, an 8"x8" dry-stacked pier has failed leaving only 4x4 wood posts to provide the support for the dropped girder. There are three such posts as seen in the next picture.

The post seen to the left of the failed brick pier serves the front wall and will be discussed in greater detail in photo caption #11.

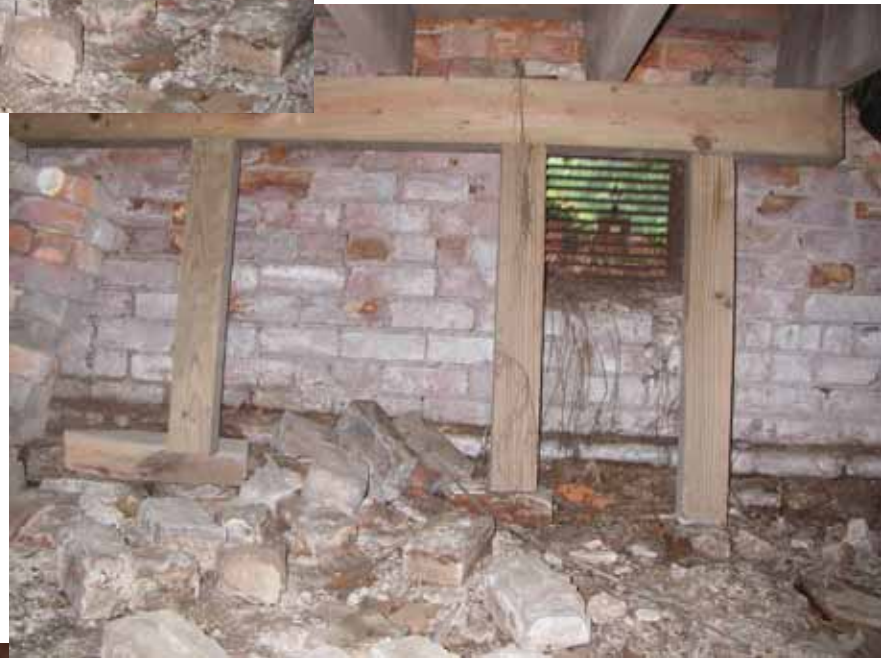
Photo #10

All three of the 4x4 wood posts assigned to support the dropped 4x6 girder are still in place, but are doomed to failure if not replaced. Their support at grade varies from a flat wood spreader to single bricks laid directly on the top of the unexcavated crawl grade.

See photo caption #5 for the repair needed down a part of the left side of the sanctuary/nave foundation wall.

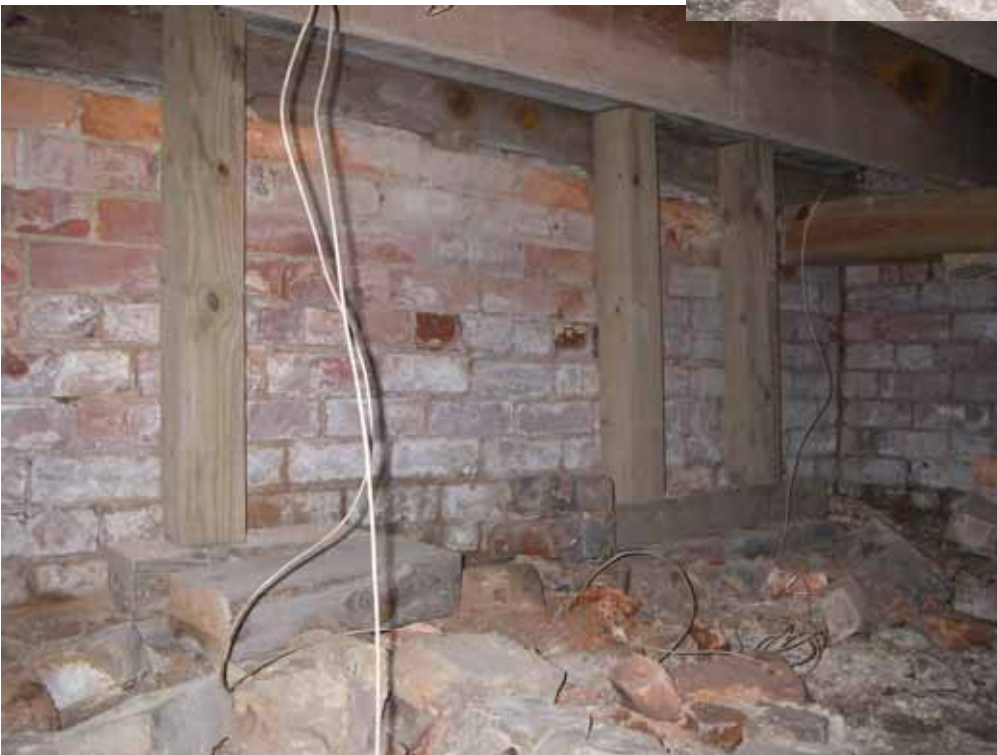
Photo #11

This picture shows the left side of the front foundation wall serving the sanctuary/nave building. The 4x6 shoring member and its three vertical 4x4 posts provided temporary support for the diagonal wood subfloor planking that formerly spanned from the rim band joist to the first interior joist. Water and insect damage to the base of the rim band totally compromised the capacity of the rim band as can be seen dramatically in the photo #13.

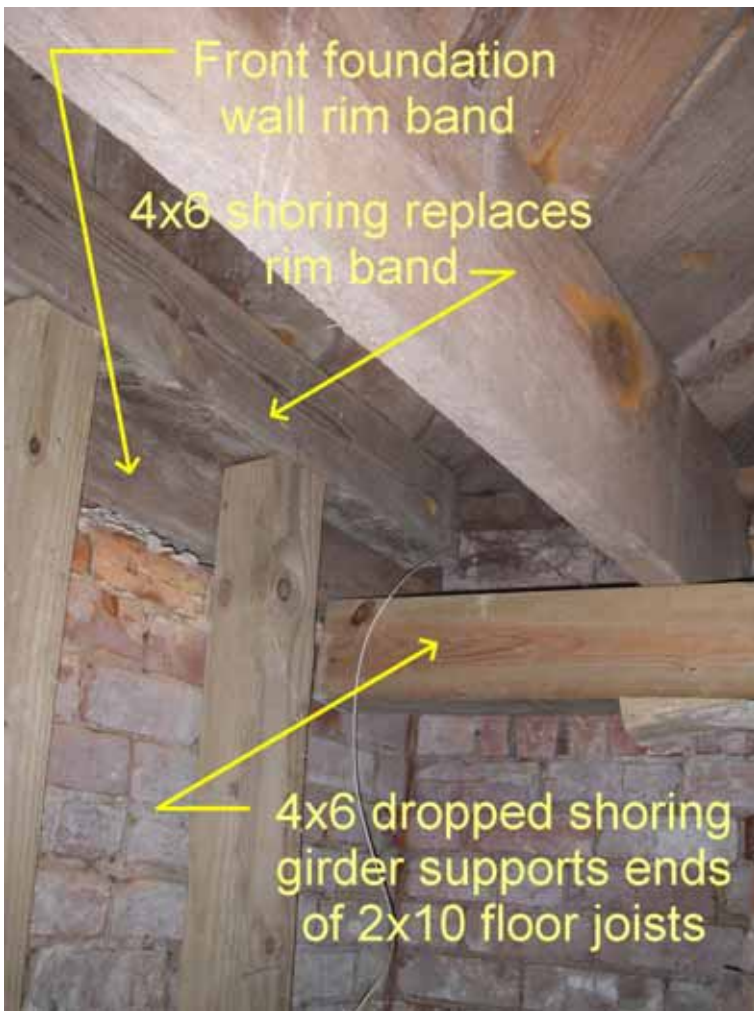
Photo #12

This picture shows the temporary shoring used behind the front foundation wall of the crawl next to the left/front corner. It shows two of the three 4x4 wood posts used to support the 4x6 girder, which was installed to support the subflooring.

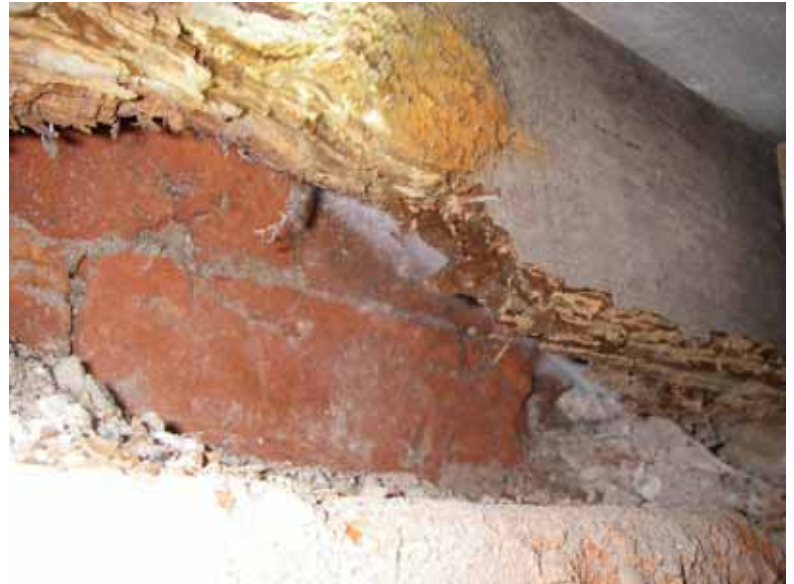
Photo #13

This is the base of the single ply, 2x10, rim band after probing with an awl. The wood disintegrated into dust. The role of the rim band as noted in the previous picture appears to have been to support only the diagonal subfloor planking. The front wall construction appears to be supported on the outer three wythes of brick.

The relationship of the foundation wall to the wall above the first floor needs to be confirmed even if intrusive measures are needed to do so. The full extent of the decayed rim band needs to be determined using destructive measures and proper support provided. As already noted, the 4x6 shoring supported by 4x4 posts is simply not working and violates a number of code provisions. Replace the band sill with a 2-ply, 2x10 pressure treated for ground contact. It should be installed tight to the underside of the subfloor planking and held in place with temporary shim stacks. Fill the gap between the new 2-ply, rim band with non-shrink grout using a metal rod to pack it and remove and voids within the mix.

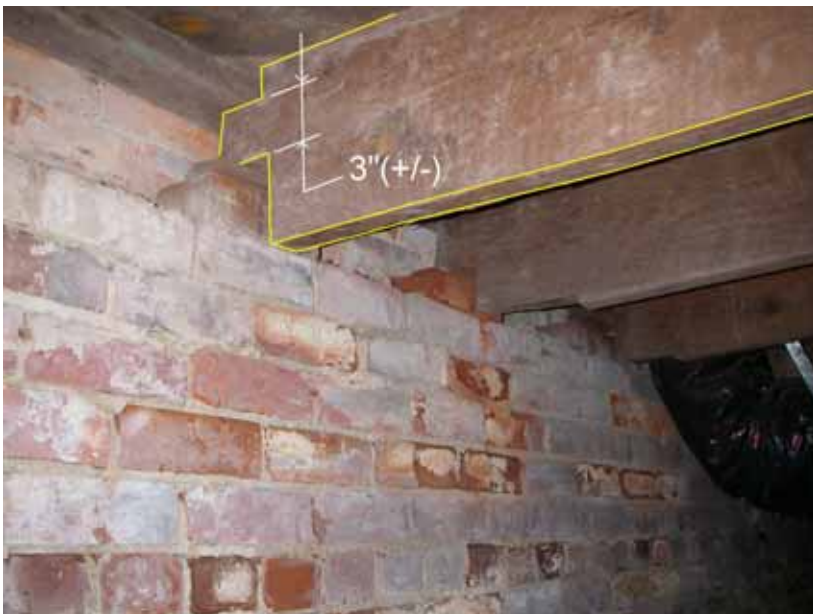
Photo #14

This picture is taken about midway down the left side of the crawl foundation wall. The joist seen here is the eighth interior joist relative to the decayed rim band seen in the previous photos. There is a continuous 2x4 ribbon board used at the top of the joists that bear on the side foundation walls used to support the diagonal subfloor planking. It is notched into the joists. That notch adversely affects the shear capacity of the joists.

As can be seen, the notching at the base of the joists is a far more serious matter due to its depth. Typically, notches at bearing should be limited to one quarter of the actual joist depth. In other words, the actual depth of the 2x10's is 9.75", so the notch at the base should be no more than 2-7/16" assuming there are no other notches. As highlighted in this photo only one third the depth of the joist is available to transfer shear load to the supporting brick ledge. See the following page for additional discussion.

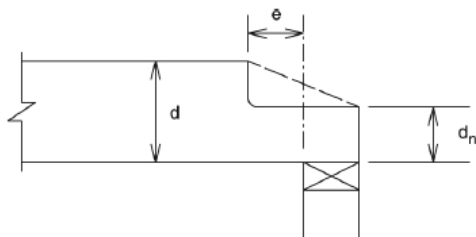
Photo #15

The data seen on the left is taken from the National Design Specification, which governs all wood construction. Using these formulas, the shear capacity of the deeply notched (top and bottom) wood joists is less than 10% of the applied dead and live loads. This is a global problem occurring on both sides of the sanctuary/nave building.

The severity of the over-notching of the 2x10 floor joists varies, but affects more than 50% of the members. This is but one of three structural deficiencies affecting the support of the typical, 2x10 floor joists at both sides of the church. Another issue will be noted in the pictures that follow.

In consideration of this, a continuous line of permanent support is needed down both side walls of the sanctuary/nave building, but not at the transept, which will be addressed separately. This line of support should be installed in accordance with the directions given in photo caption #5, with splice joints of the 3-ply girders occurring only above CMU piers. The plies of the new dropped girder should be connected together with two rows of 10d (0.148"x3") common nails spaced at 24" on center, staggered top and bottom at 12". There should be three 10d nails stacked vertically at splice joints. The nailing should be done from the outer plies into the inner ply, meaning the girders should be rolled over to connect them together. If this is not practical, connect the three plies together from one side using Simpson Strong-Tie SDS254500 (hot-dipped galvanized) screws at the same spacing designated for the nailing. Since the framing will be continuous, the pier spacing will always be 7'-4" or less. Be sure to place a 2x8x16" long pressure treated wood shim block above all 8"x16" CMU piers to limit the clear span of the 3-ply, 2x10 to six feet.

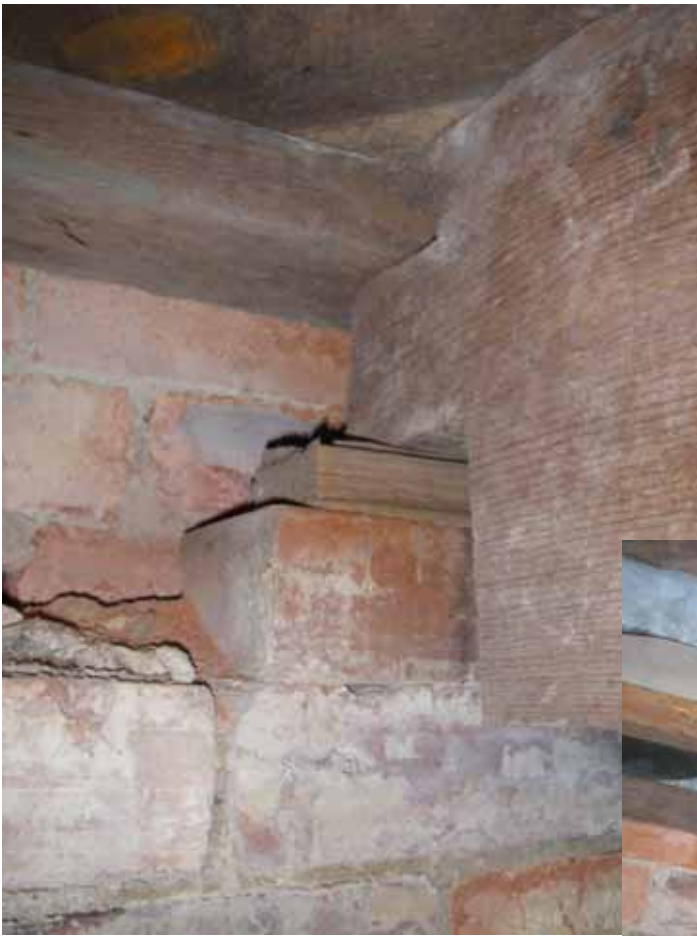
Photo #16

This is simply a close-up of the worse notched out condition of a single 2x10 floor joist.

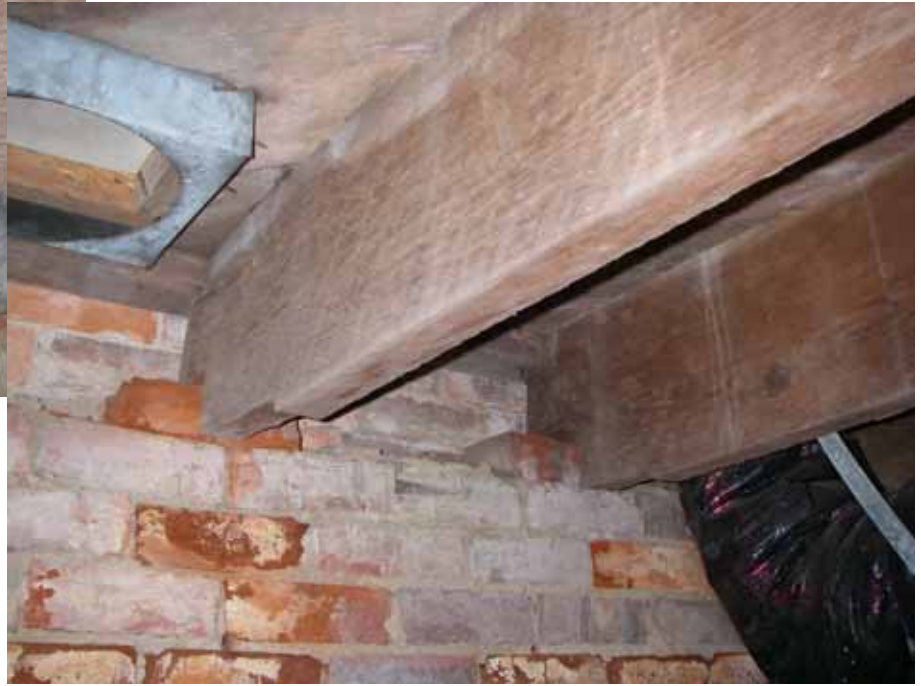
Photo #17

This is the ninth 2x10 floor joist relative to the front foundation wall of the crawl and it has a different notching pattern, but with the same adverse effect on the shear capacity of the joist.

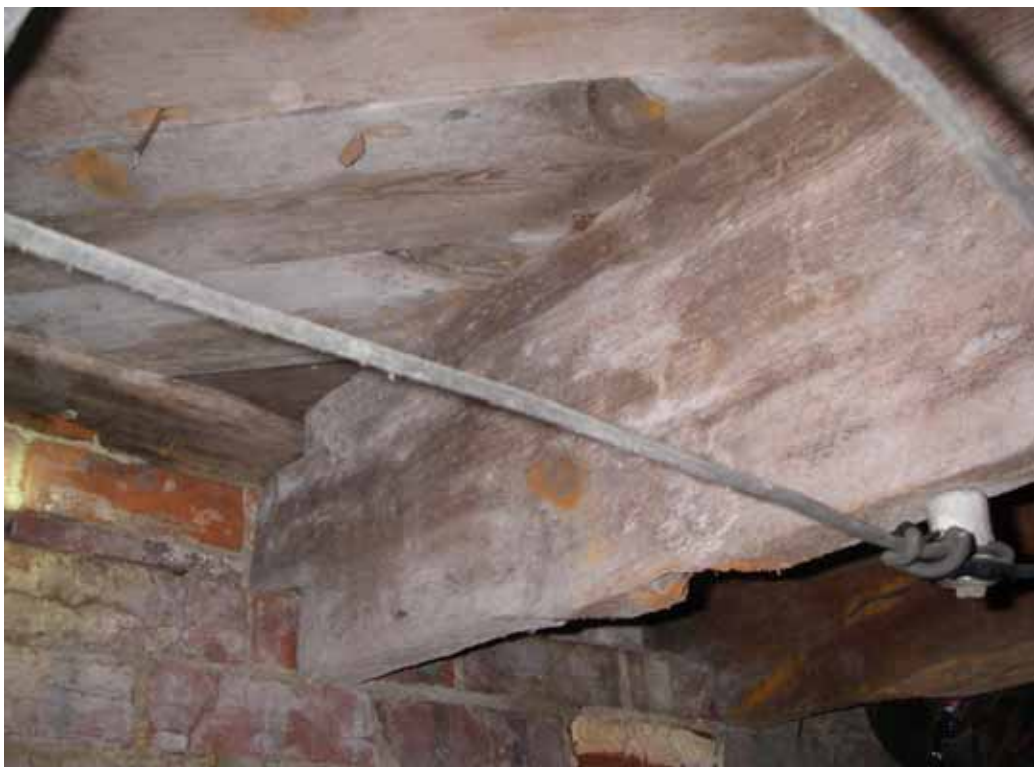
Photo #18

This picture is taken at the right side of the crawl and reiterates the observation that the over-notching is generally global in nature along both side walls. See the next picture for an exception.

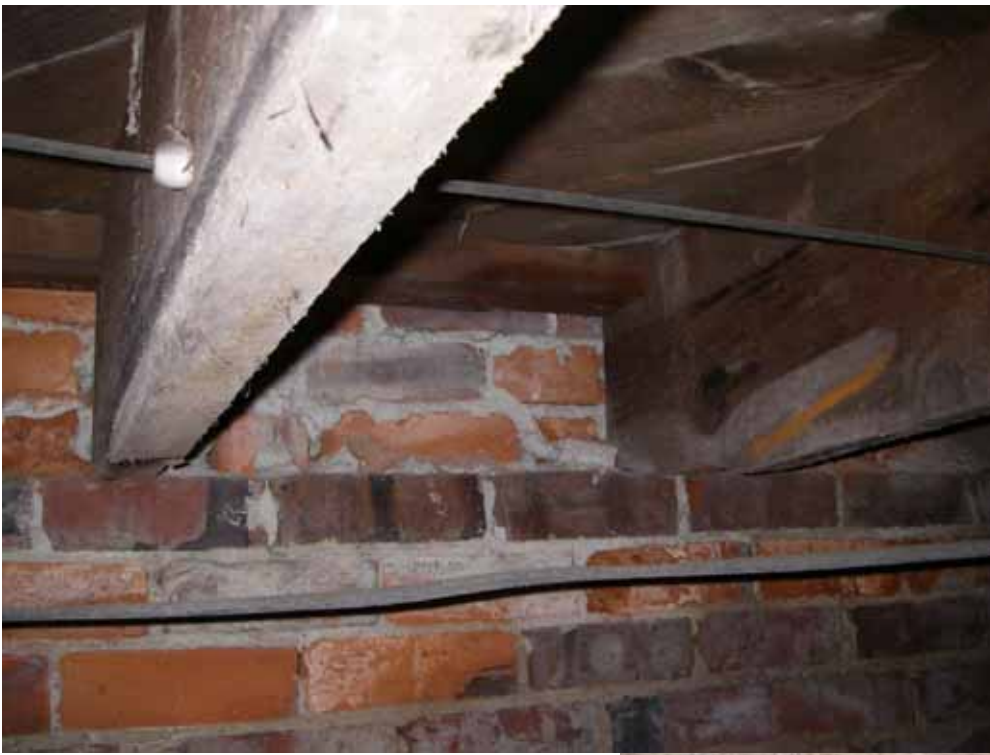
Photo #19

This picture is taken at the right foundation wall near the transition from nave to transept. Inexplicably, the joists are not over-notched at the bottom. While they are notched at the top (the compression edge), they have sufficient shear capacity. While this is the exception and not the rule, the new 3-ply perimeter dropped girder repair may be discontinued where this condition occurs provided the rim band, ribbon board and brick support are all sound. See the next picture for an example of decay to the 2x4 ribbon band.

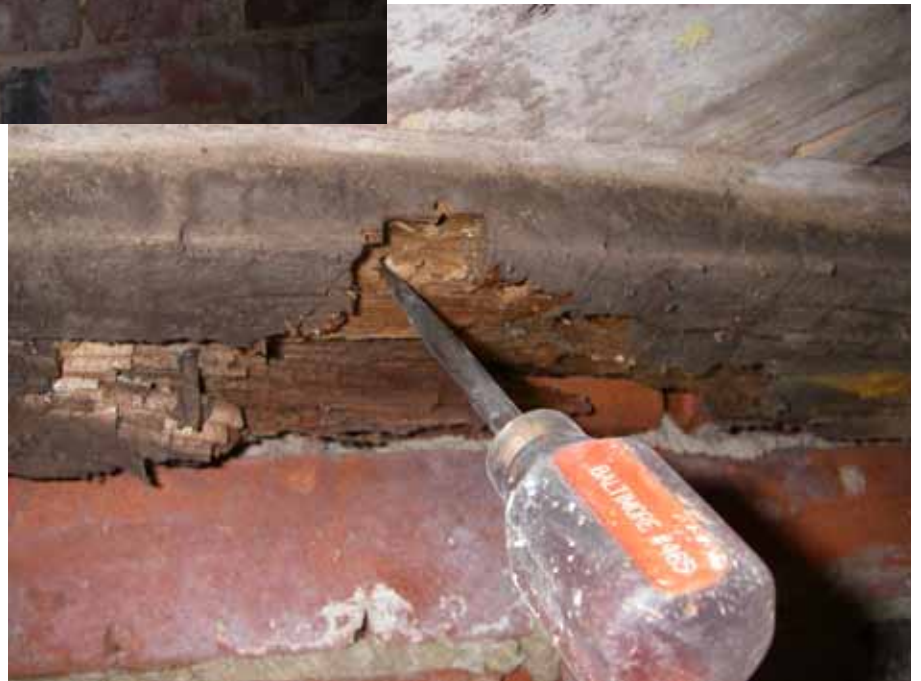
Photo #20

Not far from where the previous picture was taken is this decayed 2x4 ribbon board. This is shown to illustrate that there are a variety of structural issues affecting the proper support of the floor joists and the subfloor, so eliminating even a small portion of the new 3-ply, 2x10 dropped girder would require careful deliberation.

The decayed, structurally compromised, ribbon board should be replaced with new pressure treated wood blocking spanning between and secured to existing 2x10 floor joists down both sides of the sanctuary/nave building.

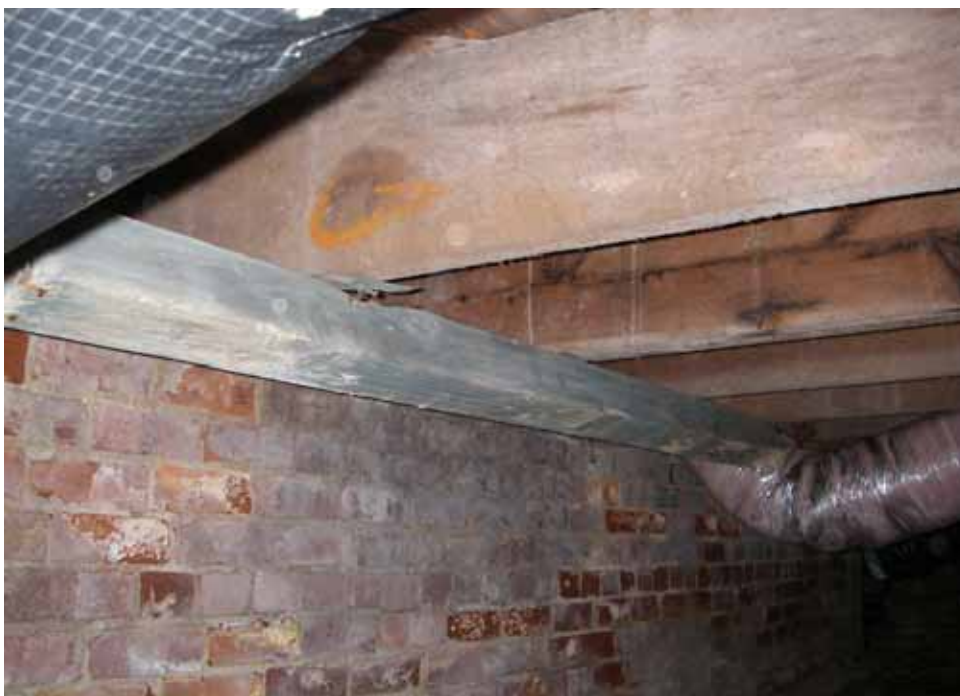
Photo #21

This picture is taken on the left side of the crawl and shows a dropped shoring board hanging from the ends of 2x10 joists it was intended to support. The joists are the 12th through the 15th relative to the front foundation wall. All of the vertical supports have fallen away.

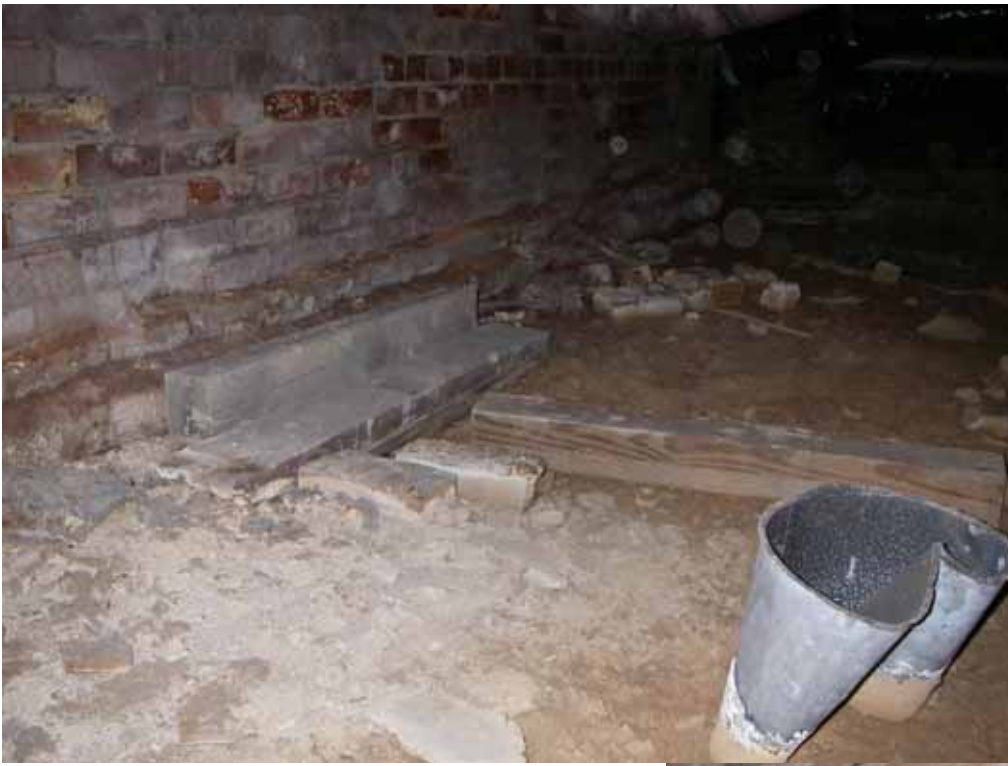
Photo #22

Here are some of the vertical supports that formerly held up the shoring girder seen in the previous picture.

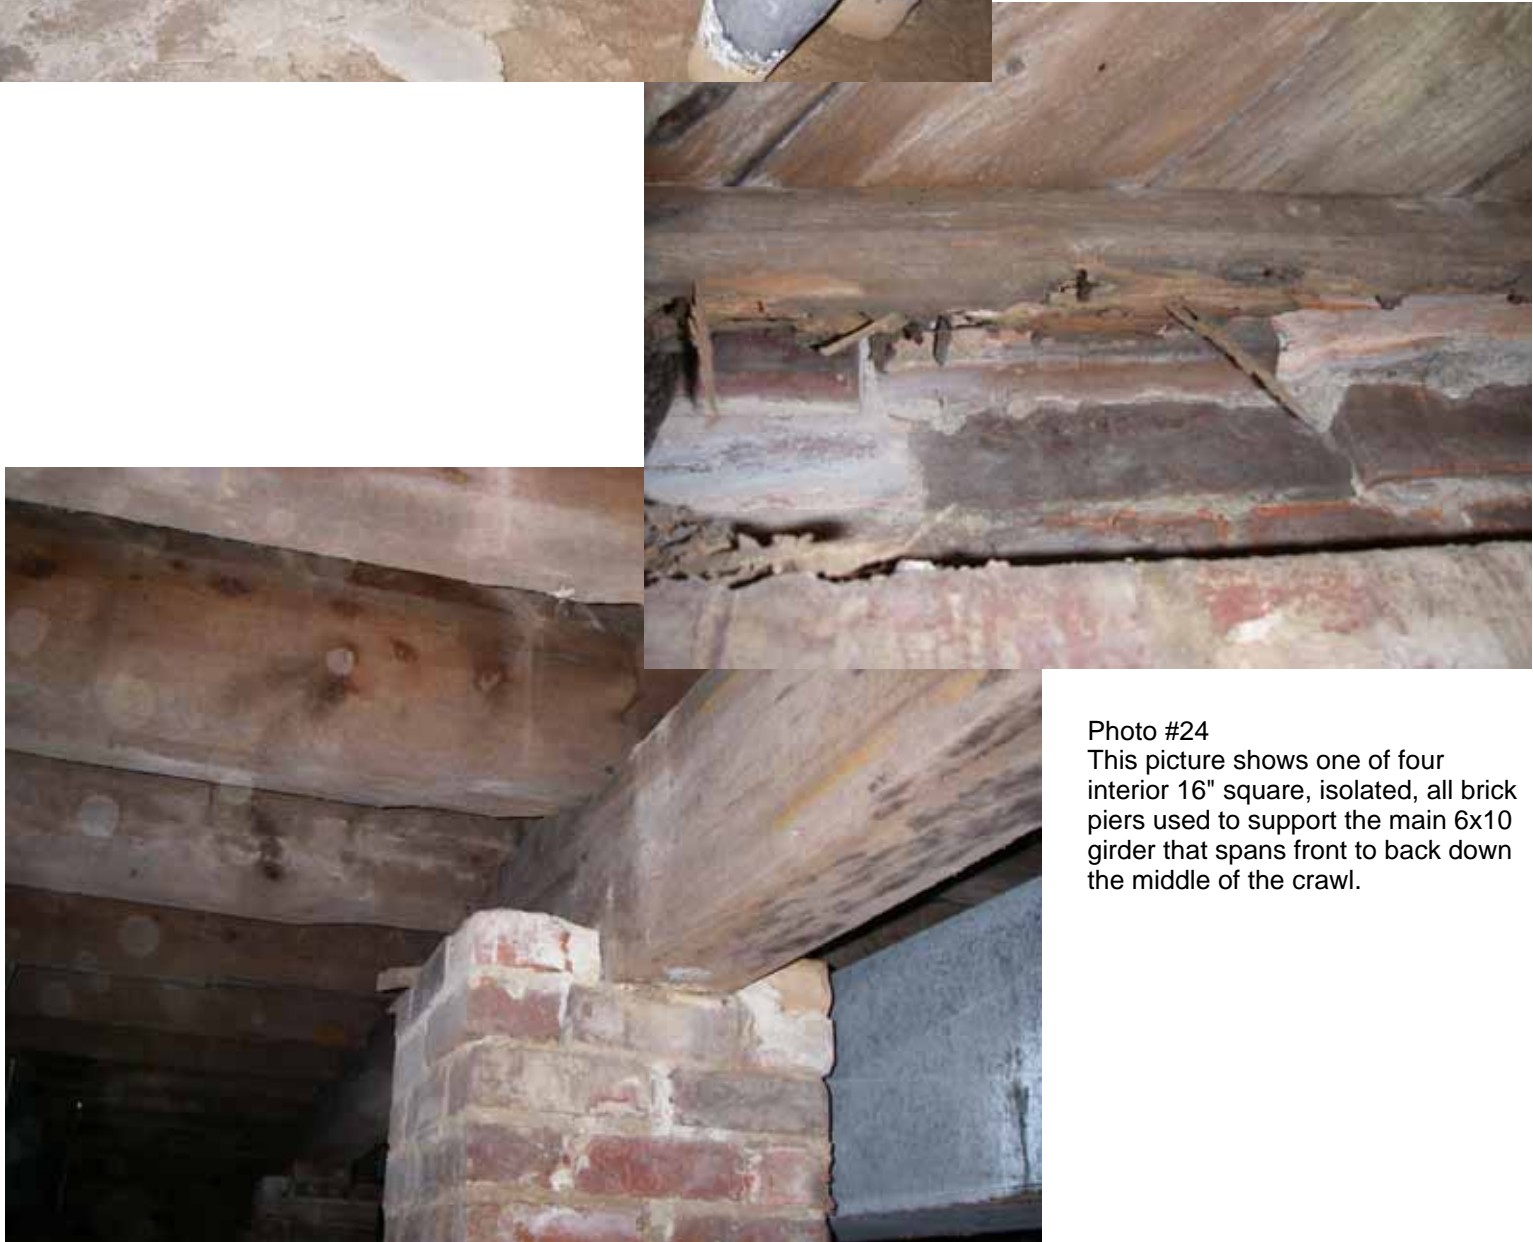
Photo #23

This is another example of a 2x4 ribbon board completely lost to decay and insect damage. This picture was taken between the 14th and 15th floor joists on the left side of the building. See photo caption #20 for repair specifications.

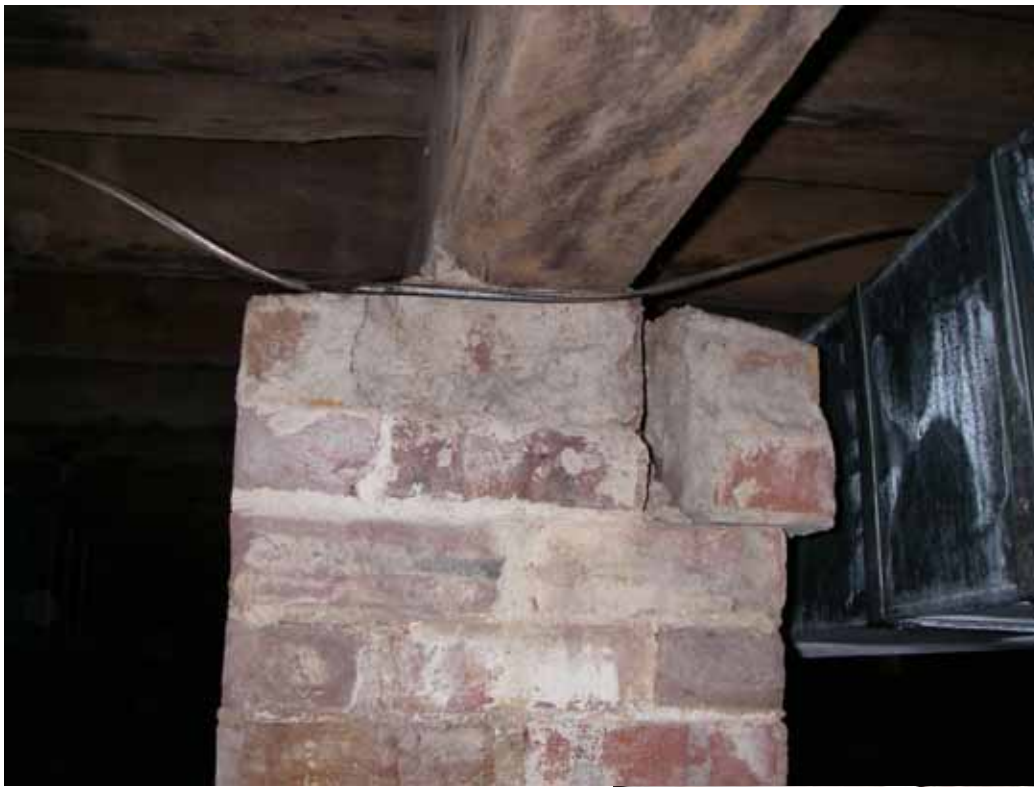
Photo #24

This picture shows one of four interior 16" square, isolated, all brick piers used to support the main 6x10 girder that spans front to back down the middle of the crawl.

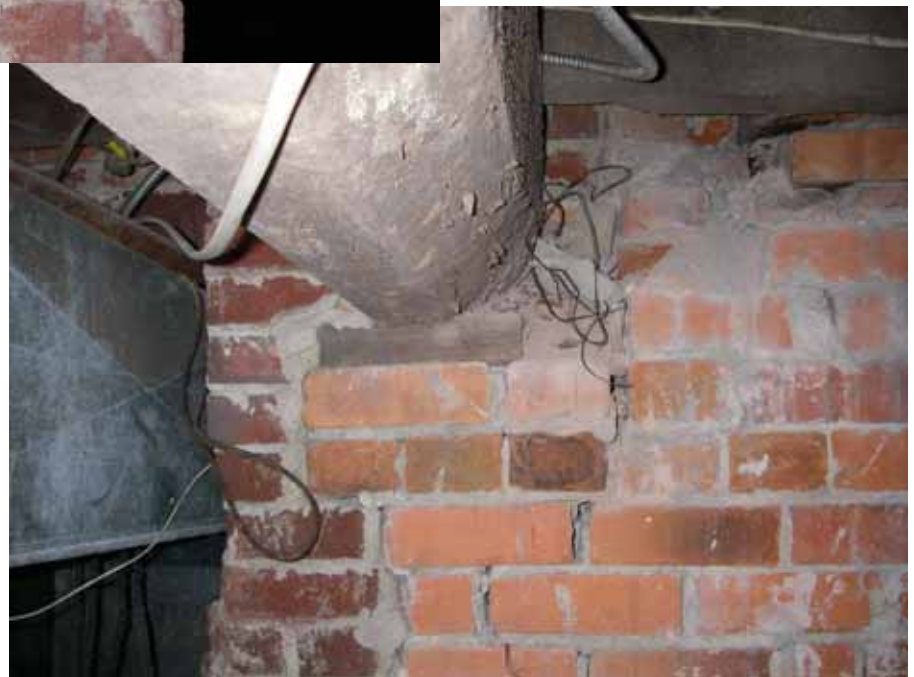
Photo #25
This center girder support pier has lost the right half of the brick that forms a curb into which the 6x10 girder fits.

Reinstall the brick using mortar that matches the existing in terms of strength and hardness.

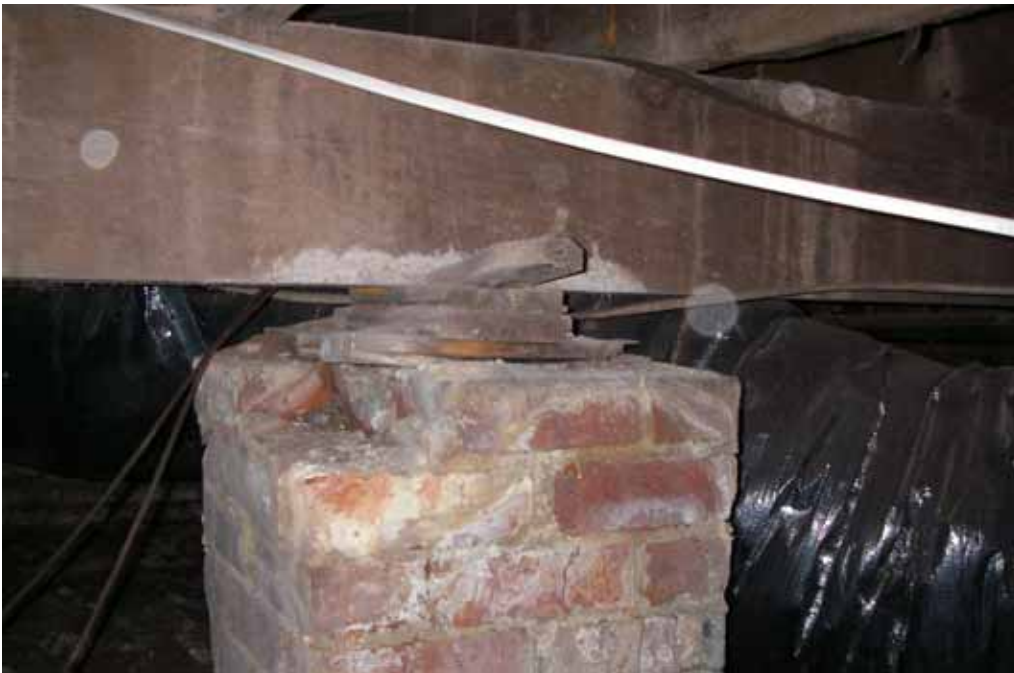
Photo #26
This picture shows the back end of the 6x10 (with considerable wane at its right bottom edge). The brick supporting the girder is distressed. Large separations are visible at both the bed and head joints.

Install a new 16" square, CMU pier with the top 8" constructed with clay brick units or solid solite block. The footing should be poured-in-place concrete measuring 30"x30"x12" thick. The new pier should be located 24" from the wall seen in this picture. Repoint the brick seen in this picture in accordance with the following guidelines:

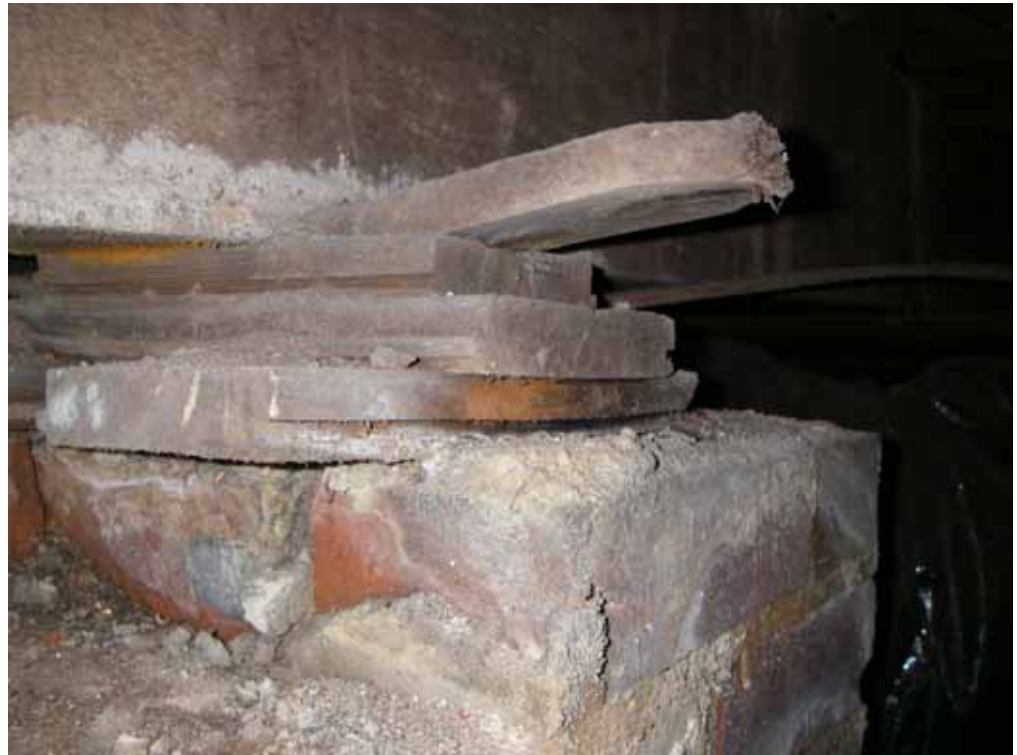
Photo #27

This pier is located under the left side of the transept in line with the left sanctuary/nave left foundation wall. The wood shims atop the isolated masonry pier supporting the middle of a 6x10 girder are improperly utilized. See the next picture.
