**St. Paul's Episcopal Church
116 South Church Street
Monroe, NC 28112-5605**

**Limited Structural Observations
for
Kyle Dunn**

**by
A. Wynn Yates, PE
Yates/Starnes Engineering, PA
3300 Elstree Drive
Charlotte, NC 28226
704-650-5541
wyates@yseng.com**

July 6, 2009

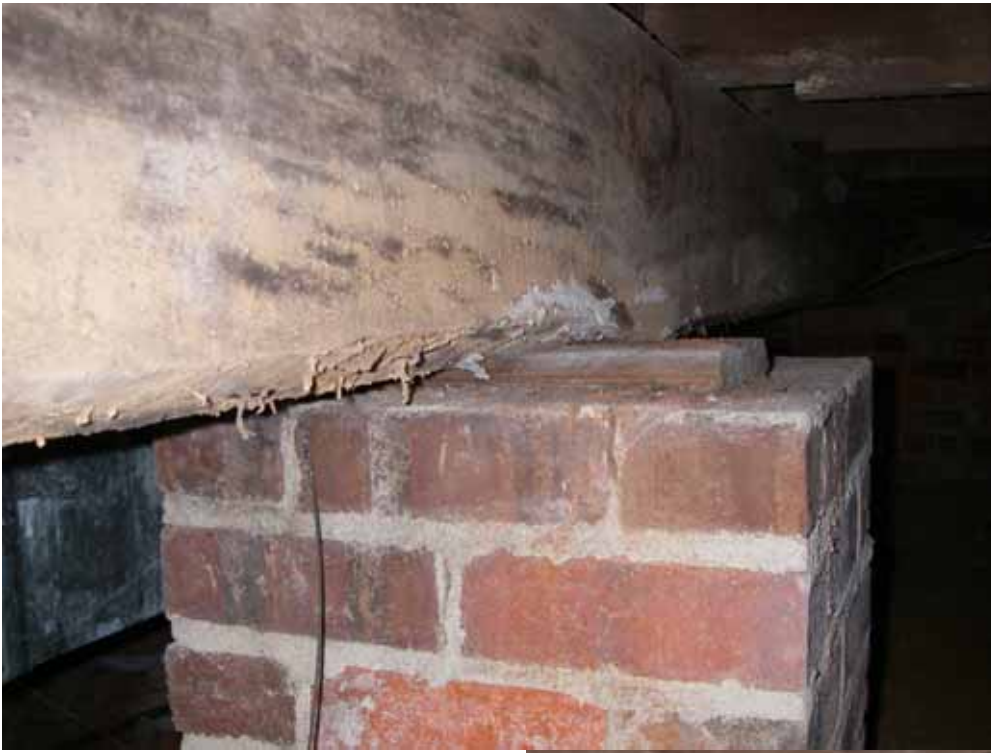
Photo #28

This is a close-up of the wood shim stack above the pier seen in the previous photo. As already seen in the case of wood supported shoring girders, wood must be fastened in place to avoid slippage. Nowhere is this more true than at girder bearing locations where shims are used to transfer loads from girders to piers. There are a host of rules used in a neighboring jurisdiction as printed below. While these rules have not been formally adopted by Union County, their appropriateness cannot be dismissed.

Reshim this girder in accordance with the following rules:

1. The shim must be completely under beam width or each ply of a multiply beam for complete support across beam width, also shim cannot project off pier.

2. The minimum width dimension of the wood shim must equal or exceed the length dimension of the shim, i.e. a 2x6 shim must be at least 5.5" long; a 2x8 must be at least 7.25", a 2x10 must be at least 9.25" long. Since full contact is required over the width of the girder supported, this also means that the length of the shim must be at least the width of the girder.

3. If wood shims are stacked in layers, they must be interconnected to prevent movement.
4. The wood shim(s) must be of the same grade and species of the girder supported. If a lower grade and species of material is used, the bearing stresses must be checked by an engineer. Shims can also be of steel provided they meet the criteria spelled out in 2 and 3 listed above.

5. If wood shims are stacked, the wood grain of each shim must be perpendicular to the adjacent layer.
6. Stacking of wood shims is limited to 4" maximum. For gaps in excess of 4", extend the height of the masonry pier below as required.

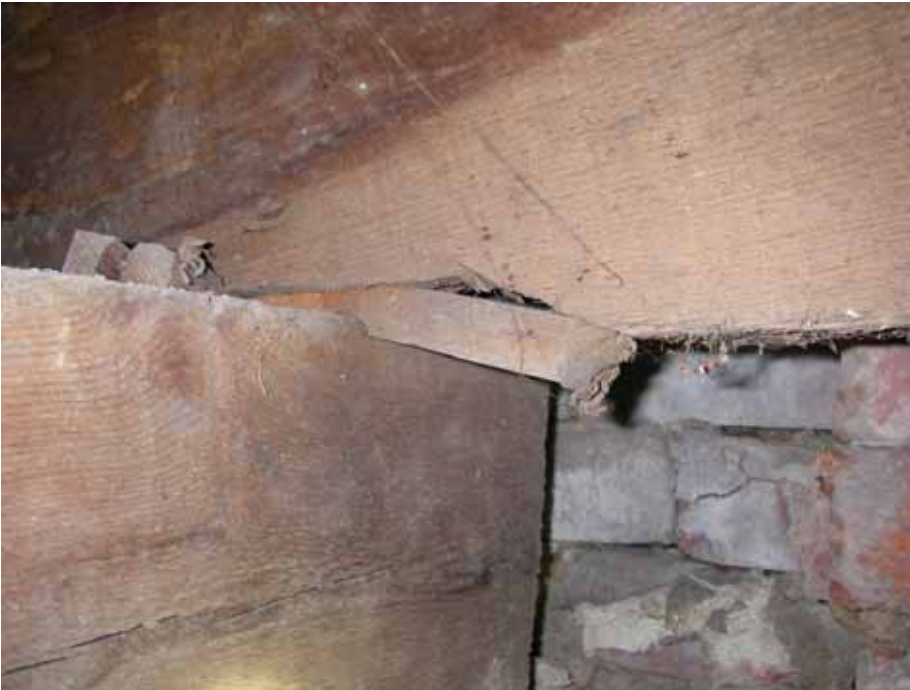
Photo #31

This picture shows white circles where tapered wood wedges were added to close the gaps between 2x10 floor joists and the 6x10 support girder. They were required because there was no poured-in-place concrete footing under the improperly utilized CMU girder support pier. Settlement ensued causing the gaps to materialize. See the following.

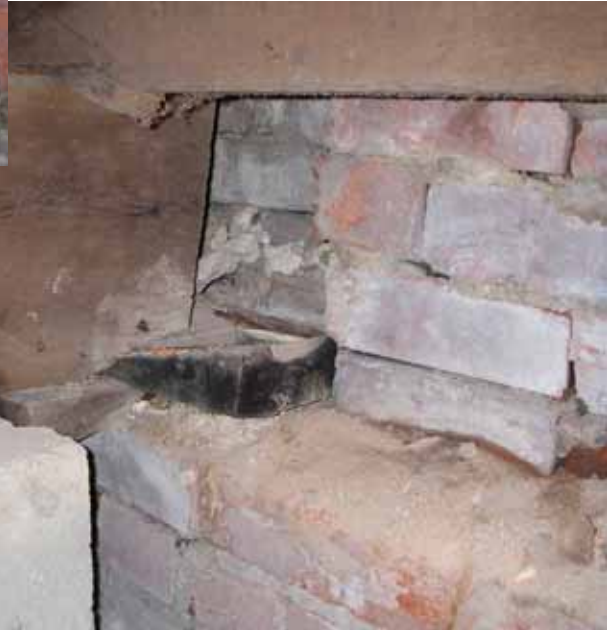
Photo #32

This is a close-up of one of the tapered wood wedges used to bridge the gap between the 2x10 joist and 6x10 girder. Note that the wood wedge is crushed due to the limited area of contact bearing typical of tapered wood wedges used as shims. Wood wedges should never be used as shims. See the next picture.

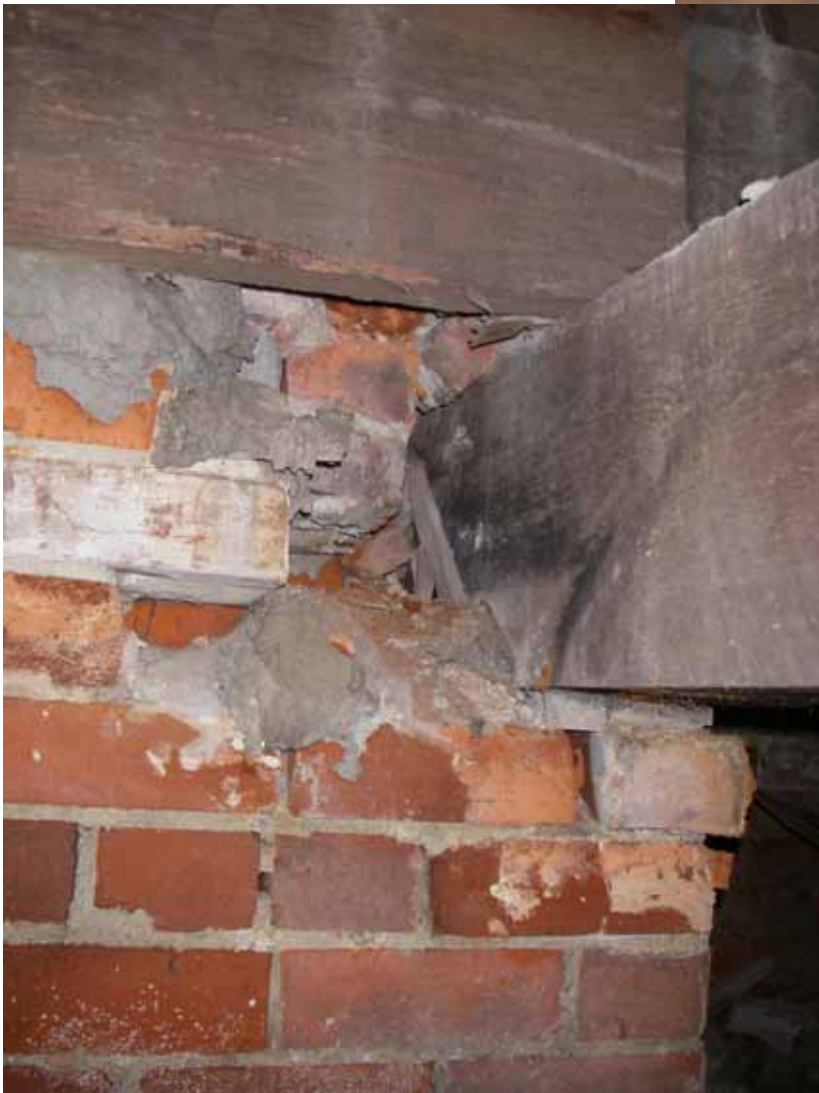
Photo #33

This picture shows wood wedges are also used above the dry-stacked CMU corner pier seen in photos #30 and #31.

Reconstruct the pier in accordance with specifications for isolated piers noted in photo caption #5. Remove wood wedges and replace with steel shim stacks in accordance with the shimming rules printed in photo caption #28.

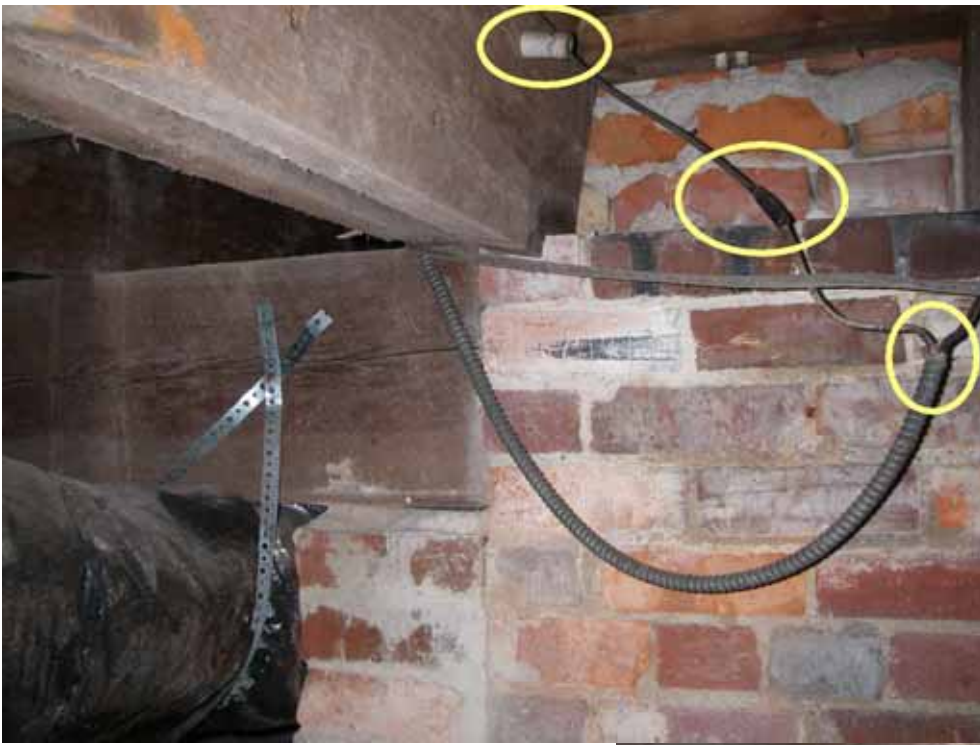
Photo #34

This picture is taken at the left reentrant corner between the transept and the chancel. The 6x10 girder is not properly supported by solid masonry.

Add a new 16" square CMU pier support in accordance with the specifications found in photo caption #26.

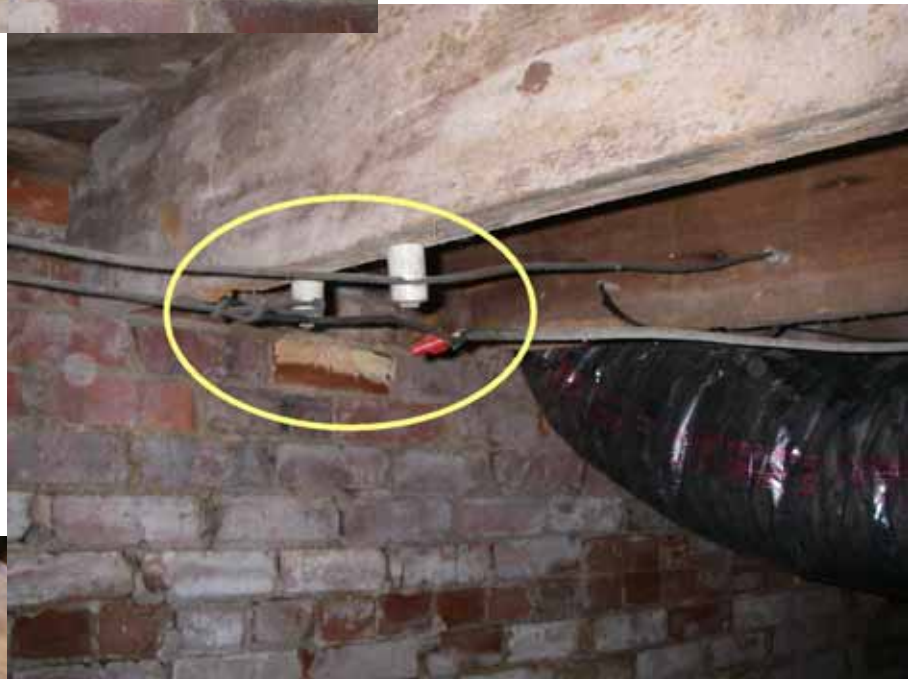
Photo #35

This picture shows the reentrant corner of the right transept and the sanctuary/nave where the support of the 6x10 is reasonably sound.

The yellow highlights are to direct attention to electrical concerns that deserve the attention of a licensed electrical contractor.

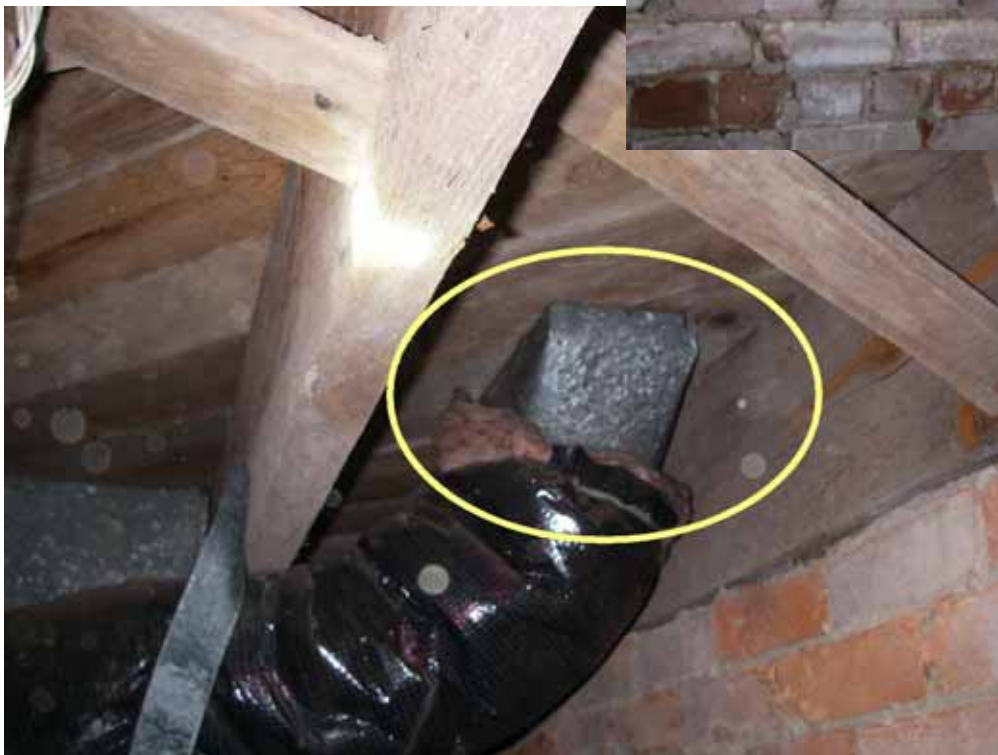
Photo #36

This picture taken under the right framing bay at a point roughly 25' from the front foundation wall also highlights a possible electrical concern, which is outside the scope of this report.

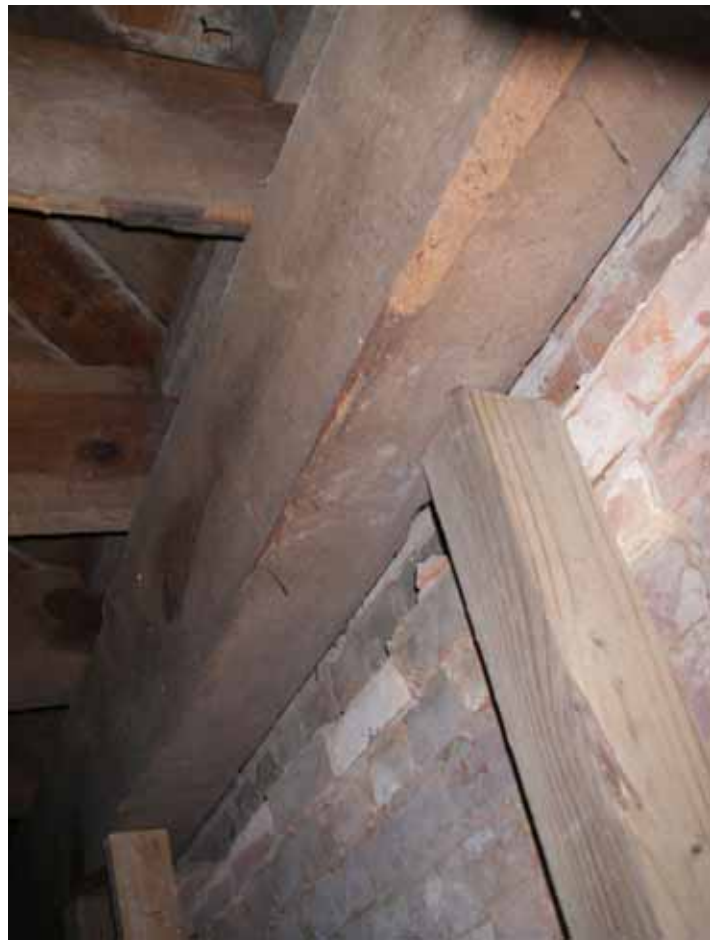
Photo #38
This picture shows the right/rear corner of the transept, where more temporary shoring was added. In many ways, this area is a mirror of the left/rear transept seen in photos #30 through #33, with the exception of wood having been used to support the 6x10 girder. See the following for additional description.
